Chapter 2

THE ACCOUNT OF WORLD TRADE CENTER 1

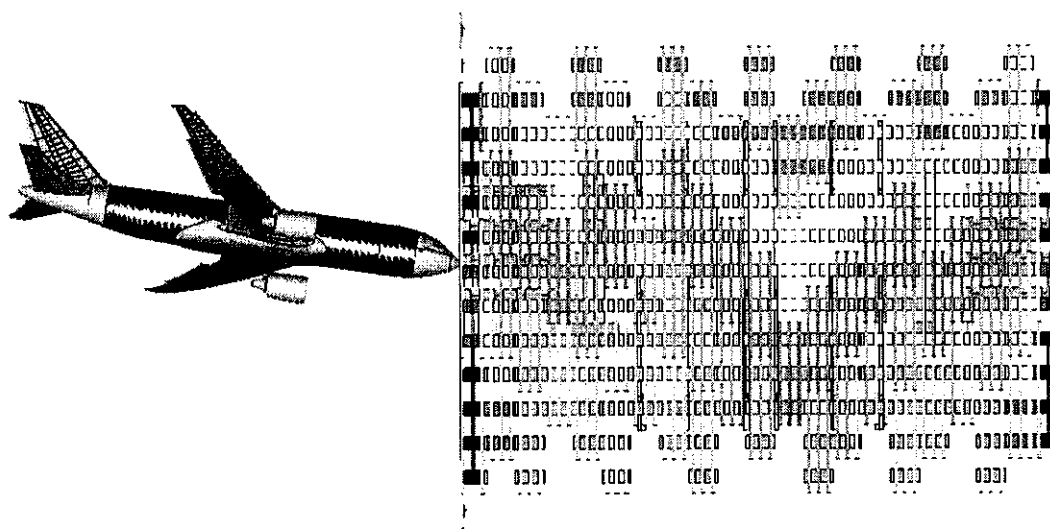
At 8:46:30 a.m. EDT, five hijackers flew American Airlines Flight 11 (AA 11) with 11 crew and 76 passengers into the north face of WTC 1 (Figure 2-1).

Figure 2-1. Simulated impact of American Airlines Flight 11 with WTC 1.

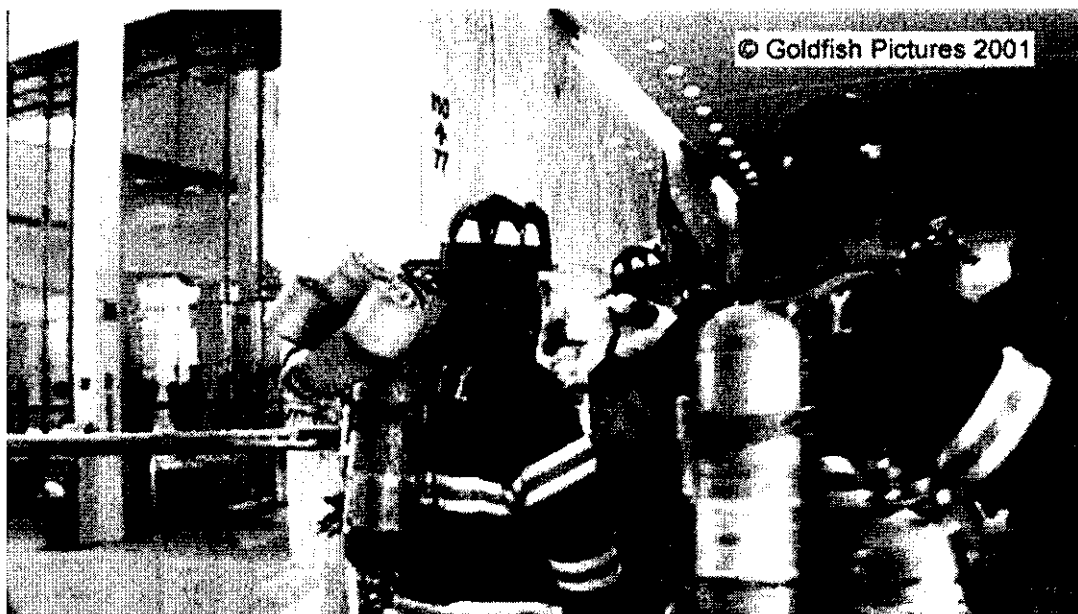
Figure 2-6. Firefighters on the scene at about 9:07 a.m.

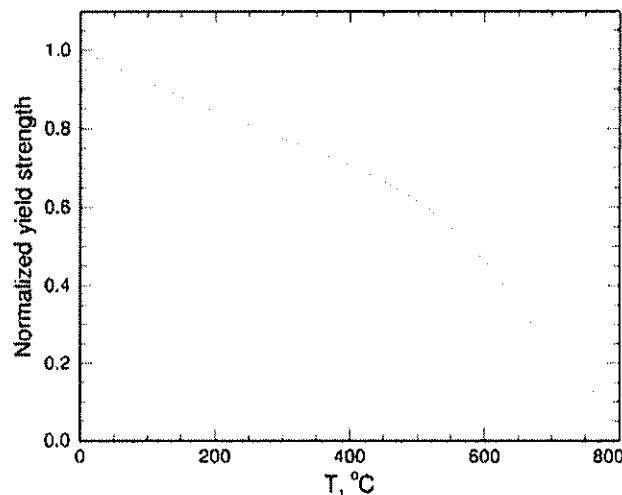
Figure 2-9. Temperature dependence of yield strength of structural steel as a fraction of the value at room temperature.

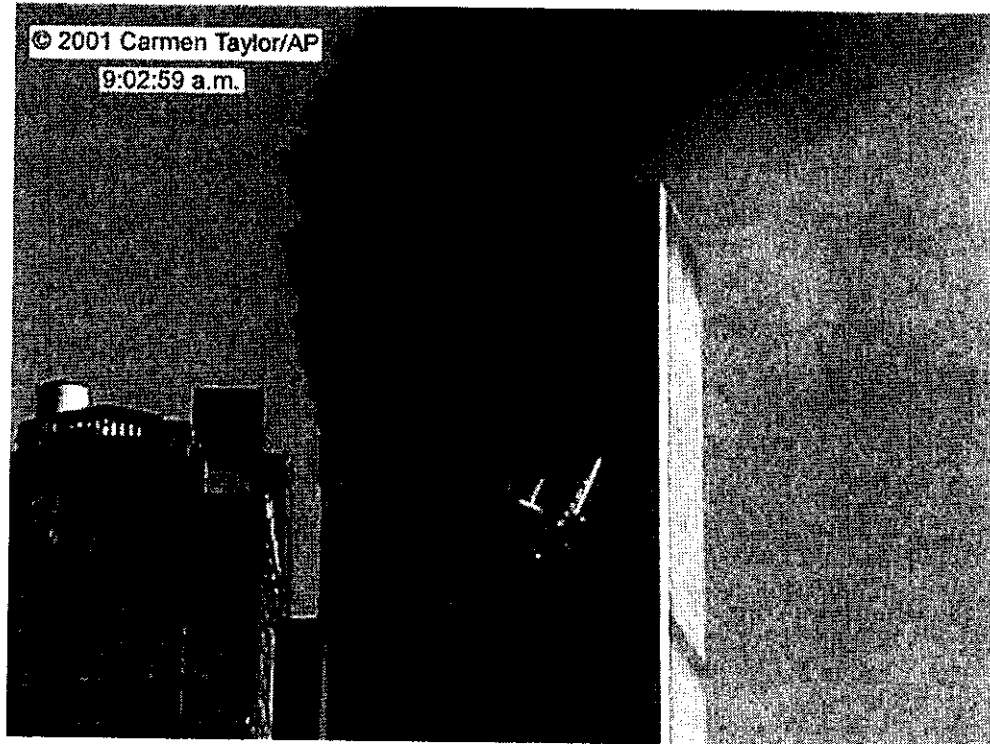
Sixteen and a half minutes after the first impact, five hijackers flew United Airlines (UA) Flight 175, with 9 crew and 51 passengers, into WTC 2 at about 540 mph, about 100 mph faster than AA Flight 11 (Figure 3-1). UA 175 was also a Boeing 767-200ER and had also left Boston, bound for Los Angeles. It flew into WTC 2 carrying about 9,100 gal (62,000 lb) of jet fuel, evenly distributed between the inboard portions of the left and right wing tanks. The cargo bay held about 9 tons of luggage, mail, electrical equipment, and food. Combining this with the combustible cabin materials and luggage, the plane brought about 14 tons of solid combustibles into the tower with it.

Figure 3-1. Imminent impact of United Airlines Flight 175 with WTC 2.

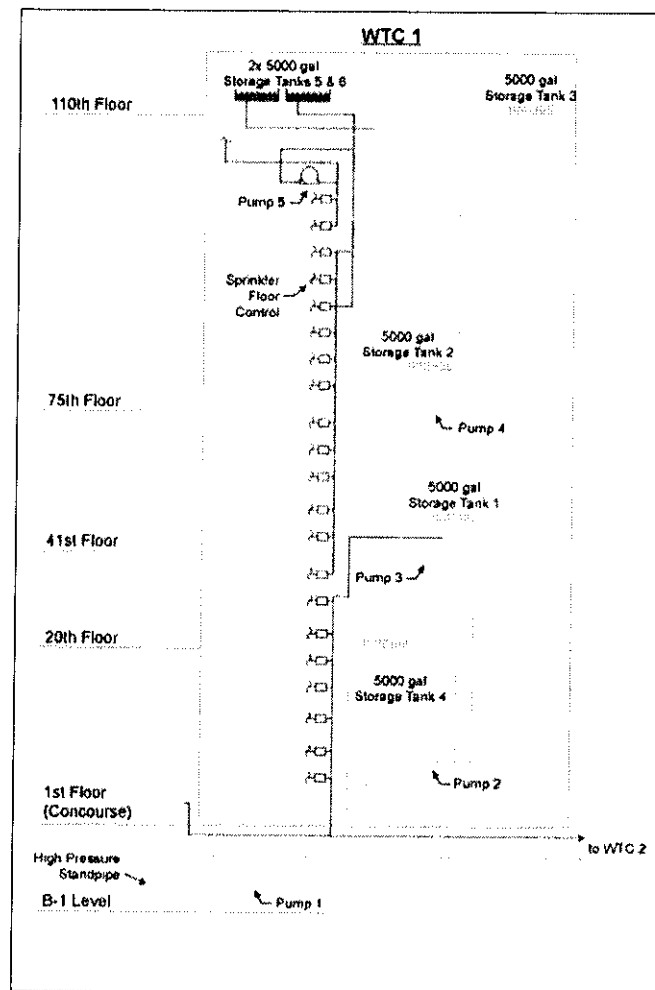
Although there were localized carbon dioxide and halon systems within the towers, the Safety Plan predominantly relied on water for containing and suppressing a fire (Figure 5–2). By September 11, 2001, automatic sprinklers had been installed throughout WTC 1 and WTC 2.¹¹ The New York City water distribution system supplied water to the complex from two independent connections located under Liberty Street to the south and Vesey Street to the north. Within each tower were six 5,000 gal water storage tanks, three located on the 110th floor and one each on the 20th, 41st, and 75th floors. These were filled from the domestic water supply in the building. In the event of a fire, the gravity-fed water would flow to as many of the thousands of installed sprinklers as had been activated. The WTC engineering staff would supply additional water upward from the city mains using manually

started pumps located in the towers; the FDNY could augment the supply using fire department connections and truck-based pumps. While there were redundant vertical supply pipes, there was only a single connection to the array of sprinklers on any given floor.

Figure 5-2. Schematic of sprinkler and standpipe systems.
